NASA Contract Report 165213

# Environmental Effects on Defect Growth in Composite Materials

**T. R. Porter**

Boeing Military Airplane Company  
P.O. Box 3707  
Seattle, Washington 98124

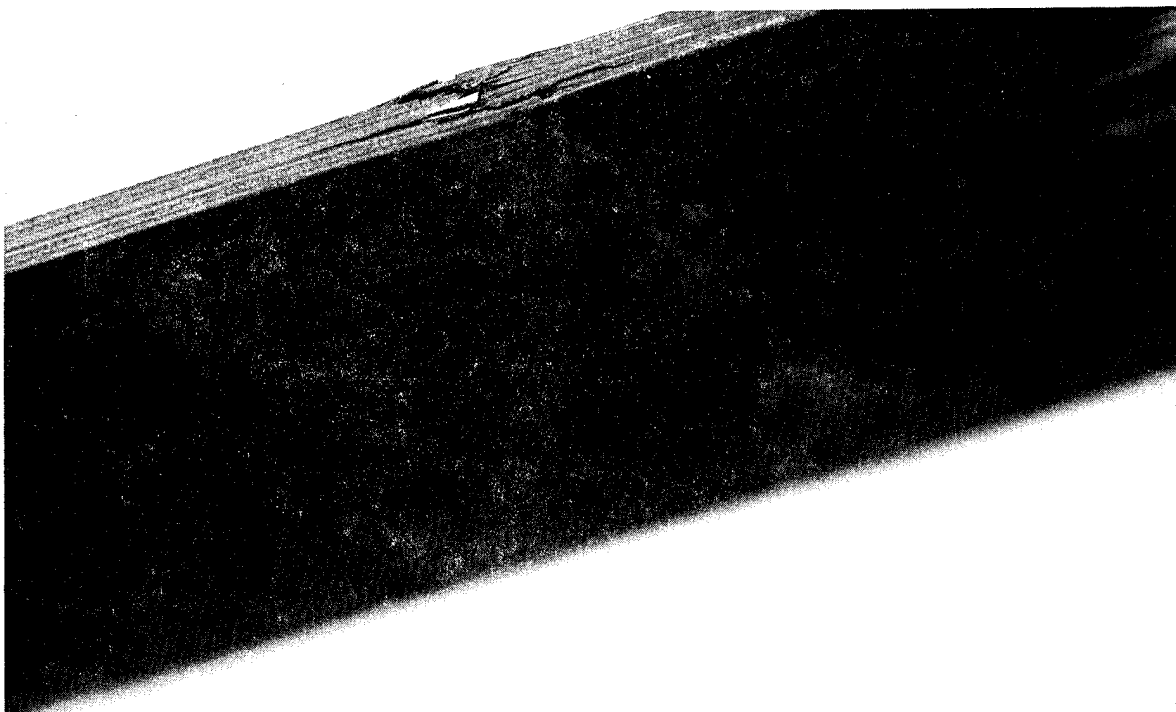
*Figure 11. Photograph of Compression Fracture Specimen*

Examination of the failed compression panel supports a notch-sensitive fracture failure mechanism. The failure initiated at the notch edge as a local compressive failure and produced local delamination, buckling and fiber breakage which lead to a local loss of load carrying ability. In a manner analogous to tension fracture, the now-larger damage size results in even higher local stresses and unstable fractures that propagate across the specimen width.

Photographs of failed specimens shown in figures 11 and 12 illustrate this failure mode. As shown in figure 11, the specimen failure emanated from the notch and run to the specimen edge. The path of this failure is normal to the panel loading. The close-up detail of the failure shows the local buckling-shear failure of the laminate. This failed region lost the ability to support compressive loading.
